All about revetment

What is revetment?

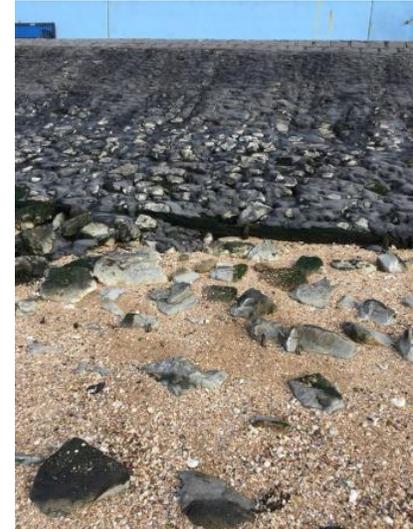
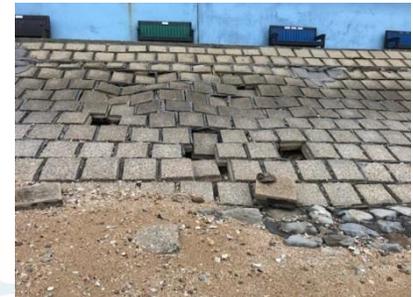
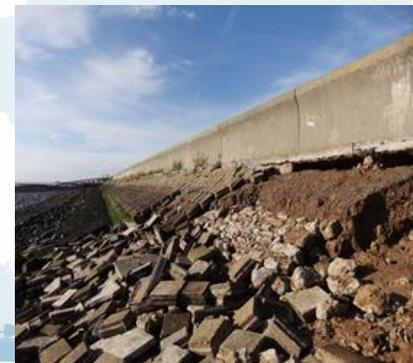
The existing revetment, shown in the adjacent photos, was not replaced or renewed during the construction of Canvey Island’s tidal defences in the late 1970s - early 1980s. The majority of the existing revetment is at least 60 years old – since the interim tidal defence repairs were completed after the 1953 tidal surge. Some other areas of older revetment date back to the 1930s.

It is formed of a patchwork of different materials, ranging from concrete blocks to ragstone and is not one continuous, complete material. This means joints between the different materials provide areas likely to erode away.

The photos on the right show how the current revetment is deteriorating:

- Falling beach levels expose the bottom of the revetment, making it unstable
- Loss of material that holds blocks together allows seawater to wash away material under the blocks, leading to sinking and holes in the revetment
- This can lead to sudden loss of revetment if exposed to large waves as experienced at Chapman Sands over the winter of 2013/14

Often minor damage will lead to more significant damage unless repair work is undertaken.

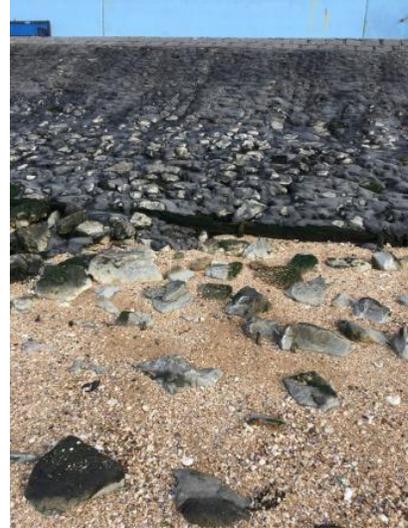
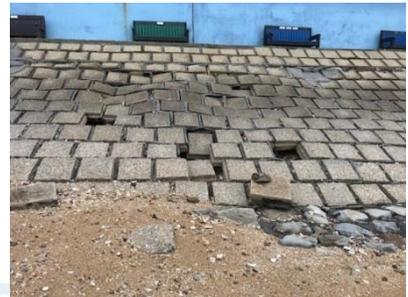
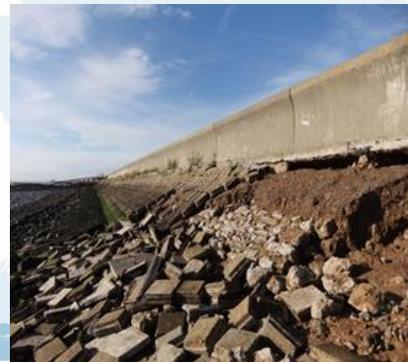
The current programme of repairs can no longer keep up with the frequency of deterioration experienced on-site. These works cannot address variations of beach level that exposes the bottom of the revetment, the toe, or with localised loss of material underneath the existing revetment.

Our current maintenance programme includes;

- Pouring a tar-like material called bitumen over areas which may be starting to move
- Pouring mass concrete in voids under the revetment
- Replacing displaced mass rocks.

These activities are currently only carried out by hand and in small, targeted areas. This is because of the width of floodgate openings within the reinforced concrete wall. This lack of width prevents modern machines accessing the revetment to carry out repair works without the disruptive need for cranes or working platforms to the landward side of the tidal defences.

Replacing the revetment along the Canvey Island Southern Shoreline will significantly reduce the risk of significant damage occurring to the tidal defence, and reduce the level of maintenance required.
